City of Chicopee

RE: City Council Minutes from the May 27, 2016 Special Meeting

Dietz and Company Architects, Inc. is pleased to present this Historic Structure Report (HSR) and the results of the team's efforts to document the history and physical condition of Chicopee City Hall. The overall purpose of any Historic Structure Report is to guide future rehabilitation, restoration, and preservation work for the subject structure. The 'Historical Information' section documents the history of the building and its changes over time. The 'System Description and Observations' portion of the report summarizes the survey, analysis and recommendations for the building.

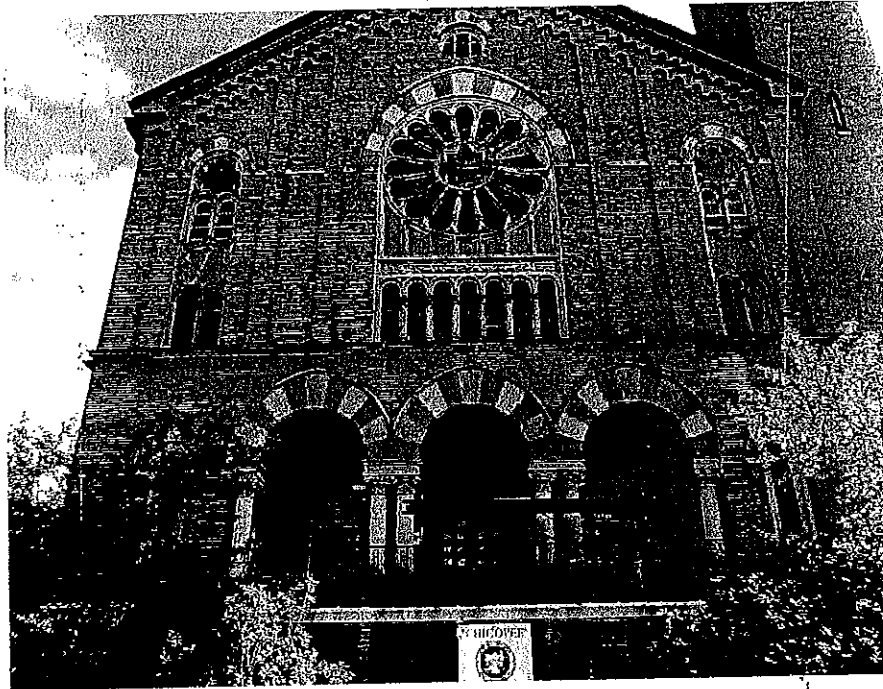
S1. West Elevation – Main entry to old City Hall.

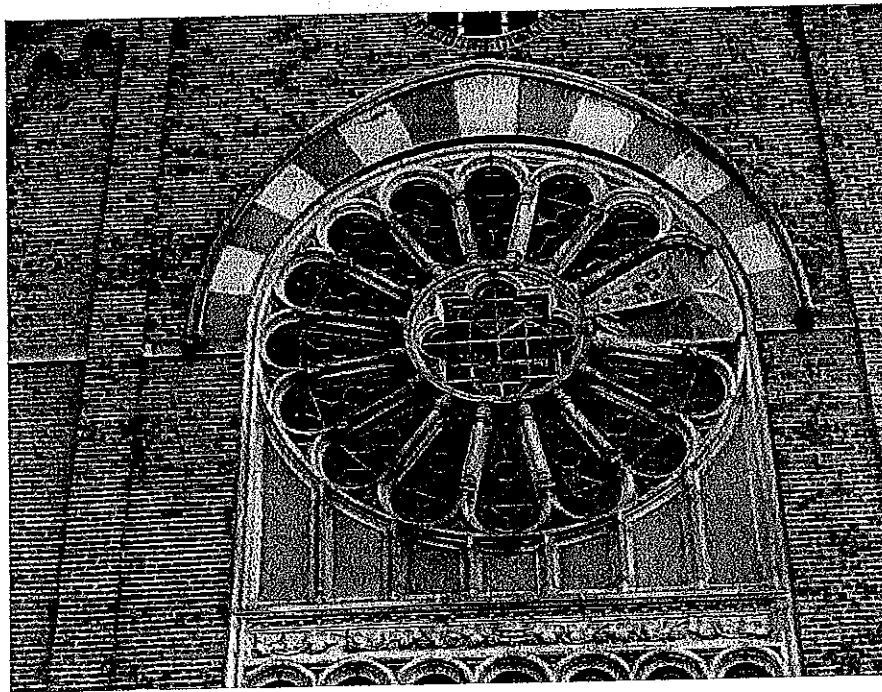
S2. Exterior of Rose Window.

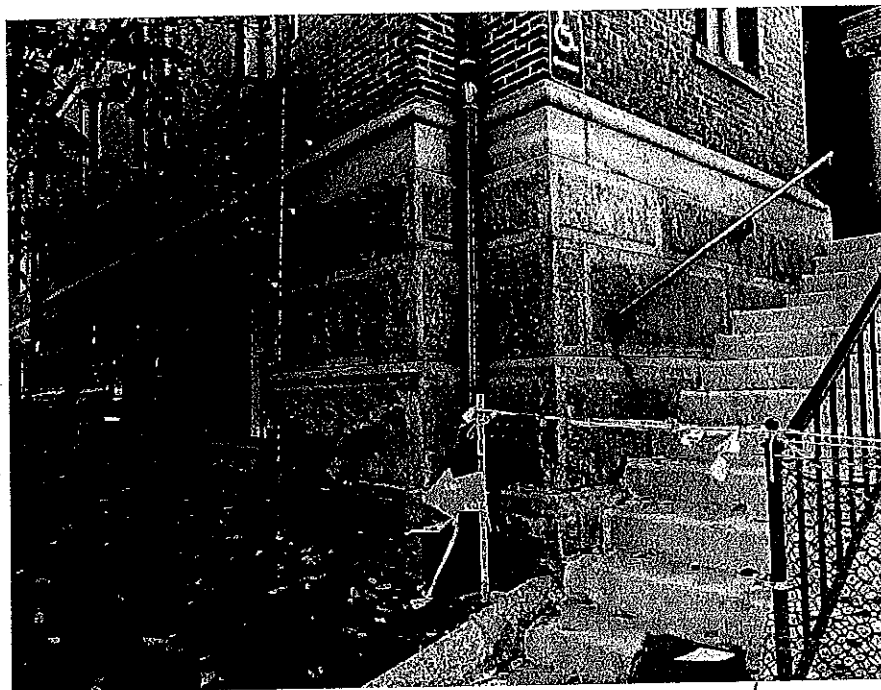
S3. Exterior northwest corner.

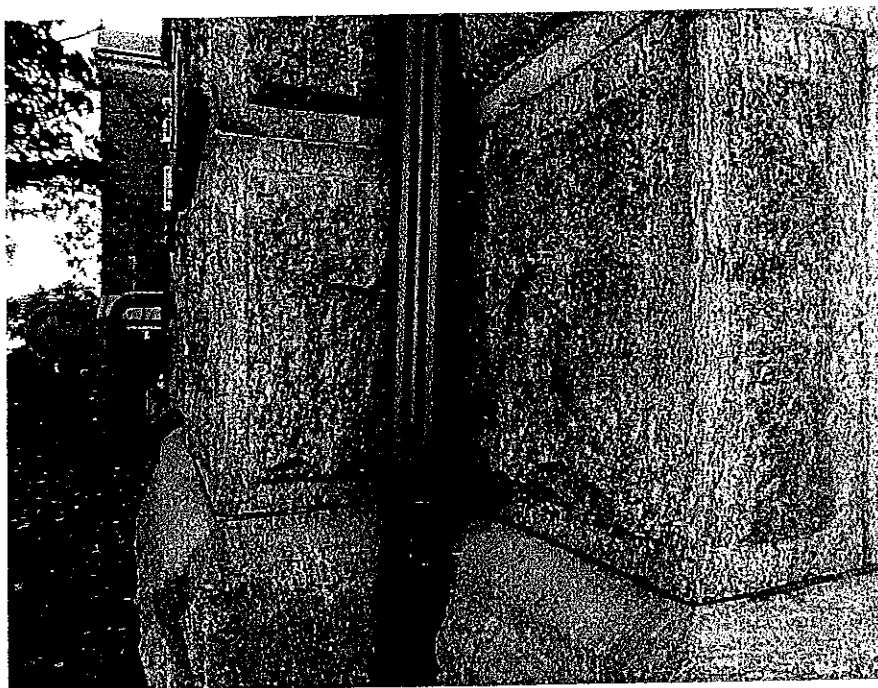
S4. Exterior Northwest Corner.

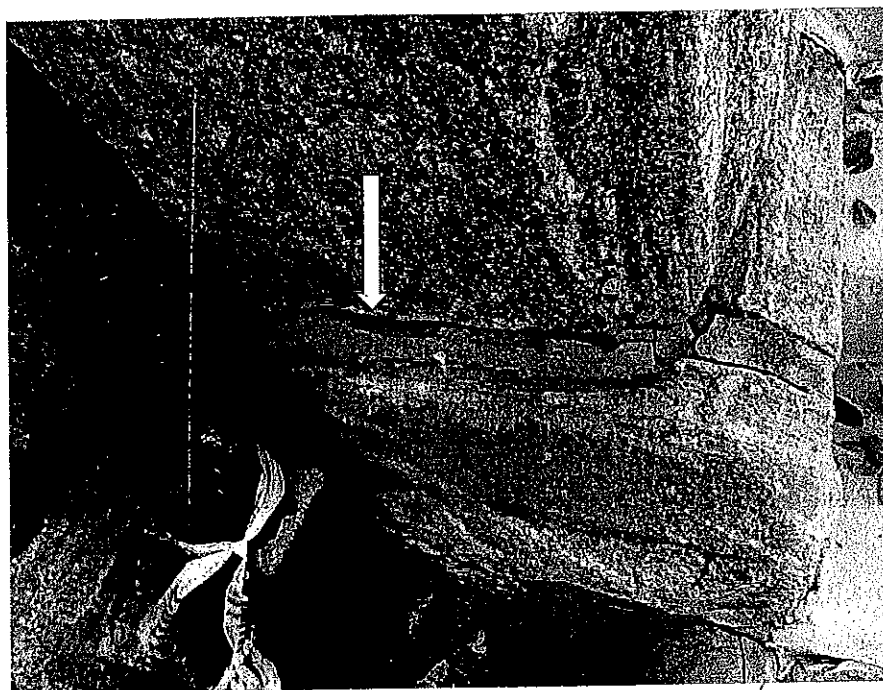
S5. Exterior northwest corner, granite veneer stone shifted $\frac{3}{4}$ " outward from building.

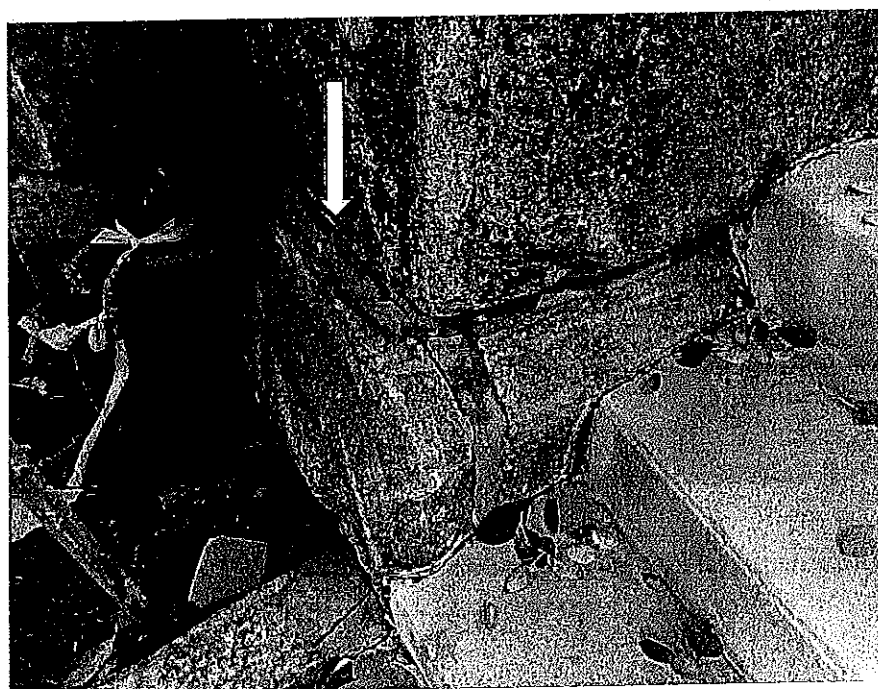
S6. Exterior northwest corner, granite veneer stone shifted $\frac{3}{4}$ " outward from building.

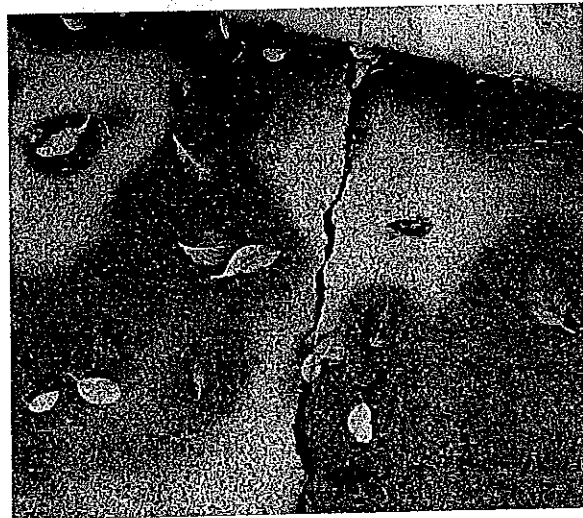
S9. Northwest corner sidewalk cracks.

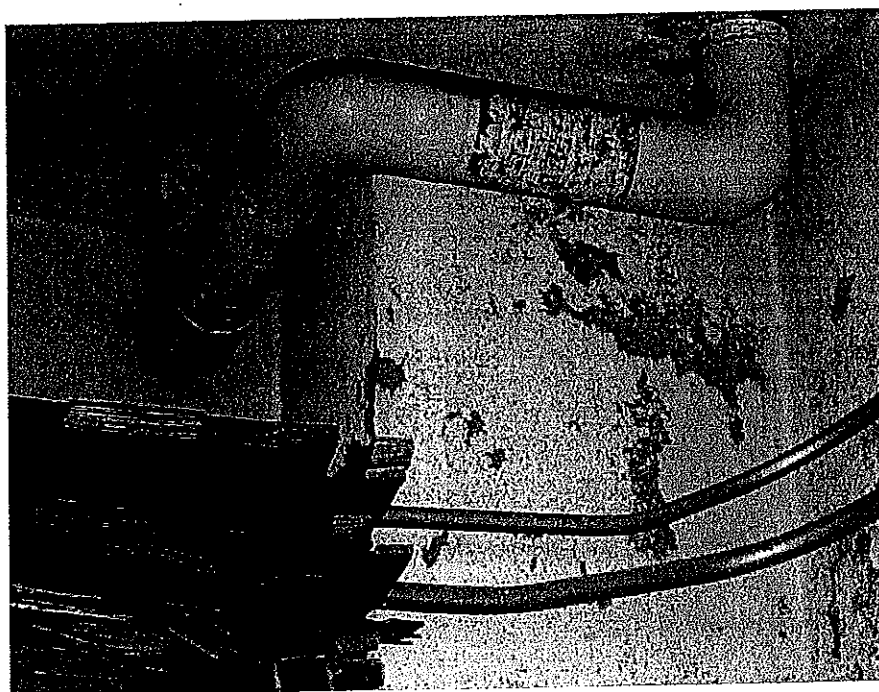
S11. Interior northwest corner.

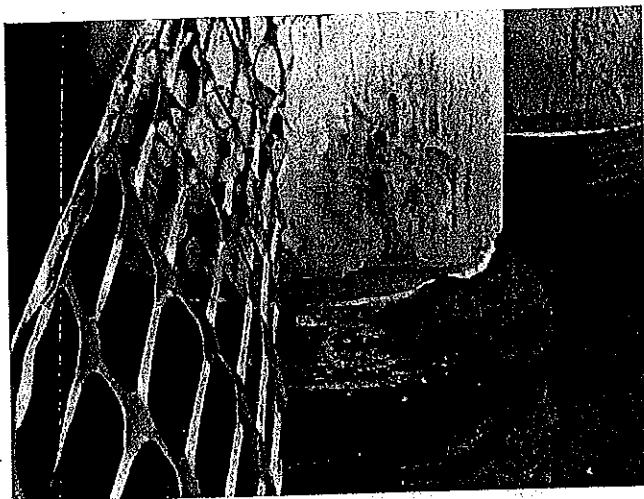
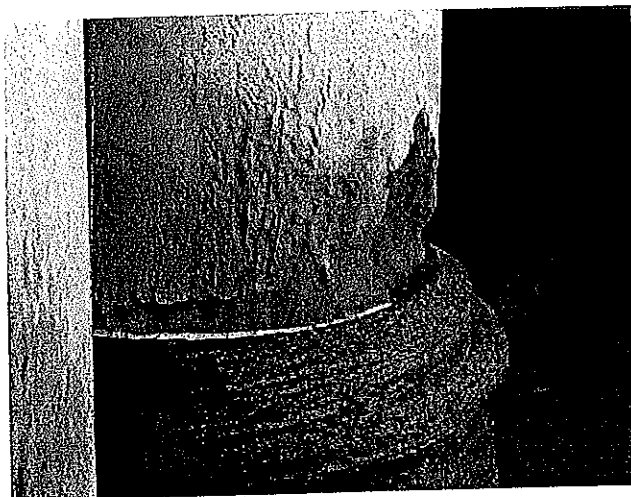
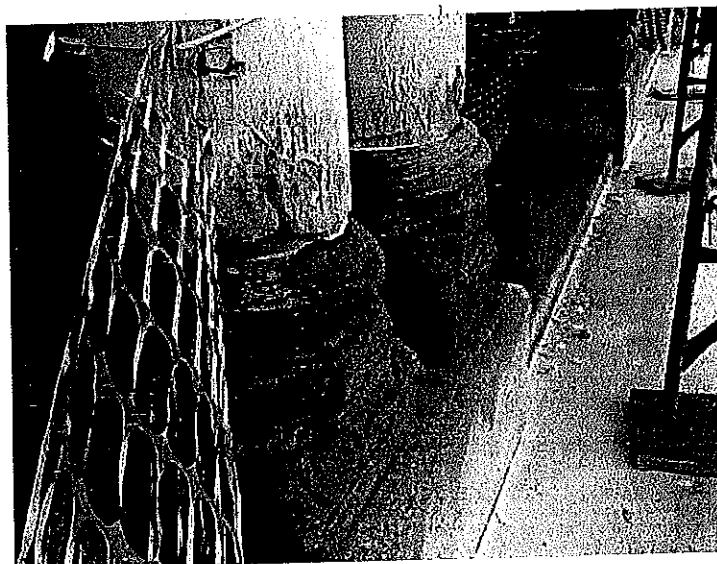
S16. West elevation, sandstone columns and brownstone bases badly deteriorated.

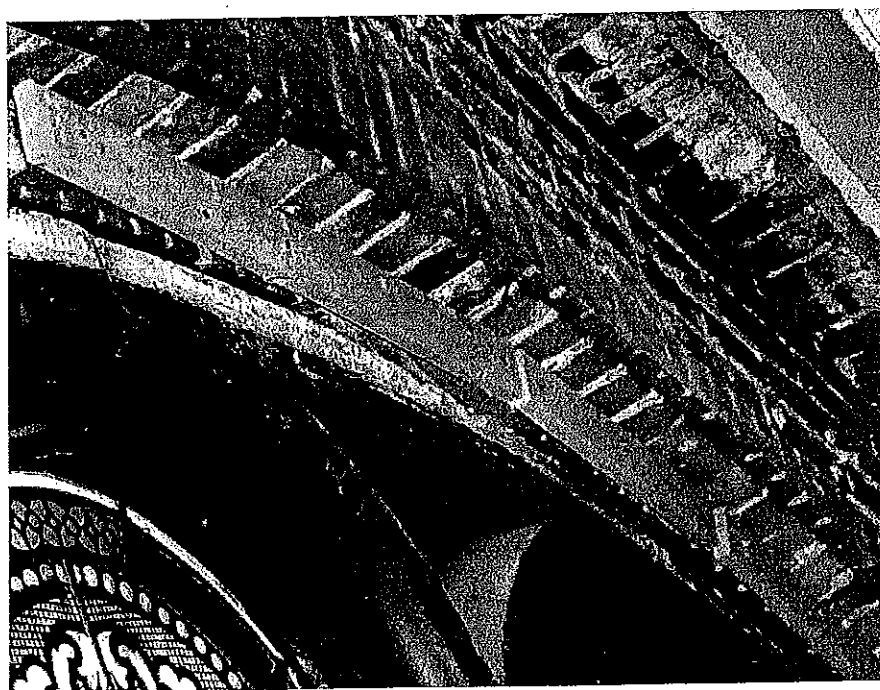
S18. Interior brick arches over Rose Window.

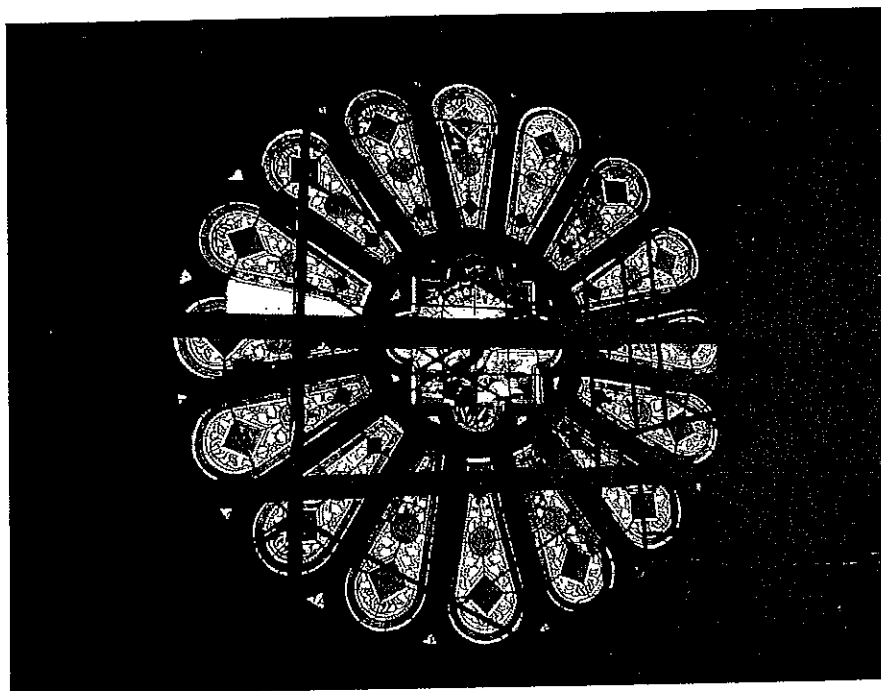
S20. Interior view of Rose Window.

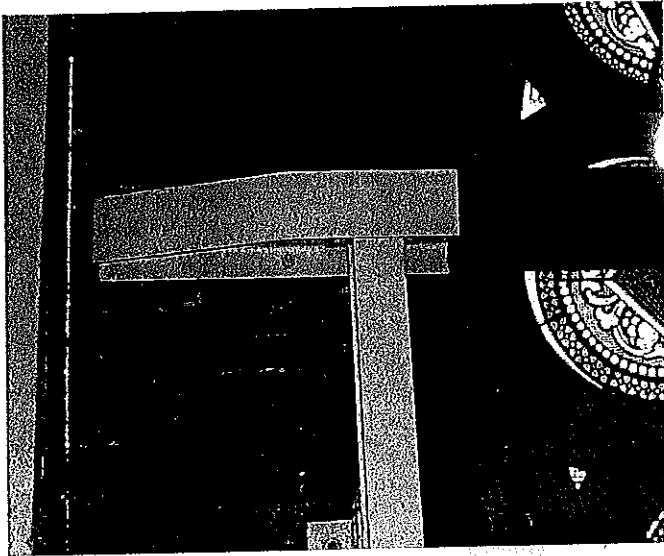
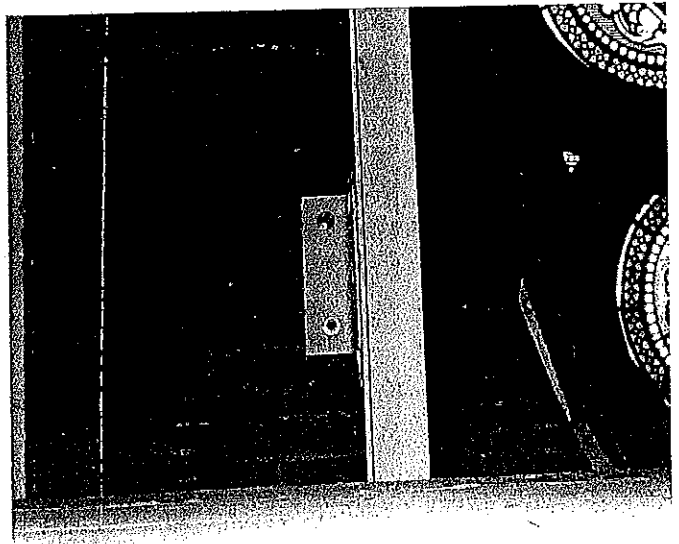
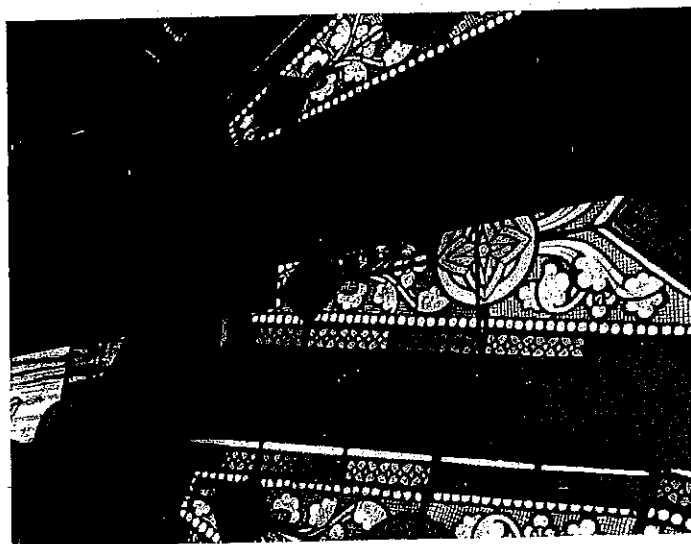
S22. Steel bracing for Rose Window interior.

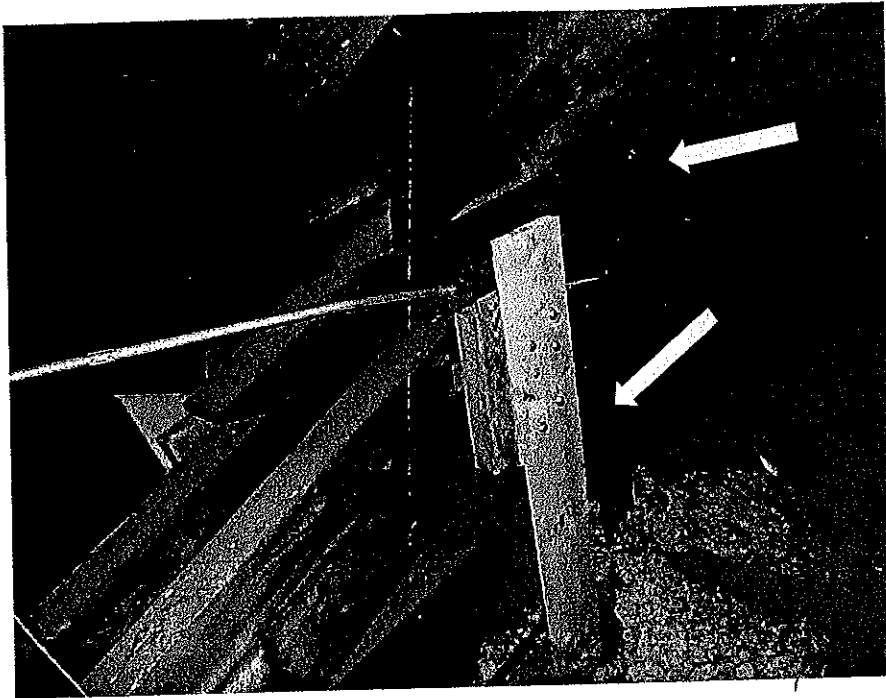
S35. Timber reinforcing of truss.

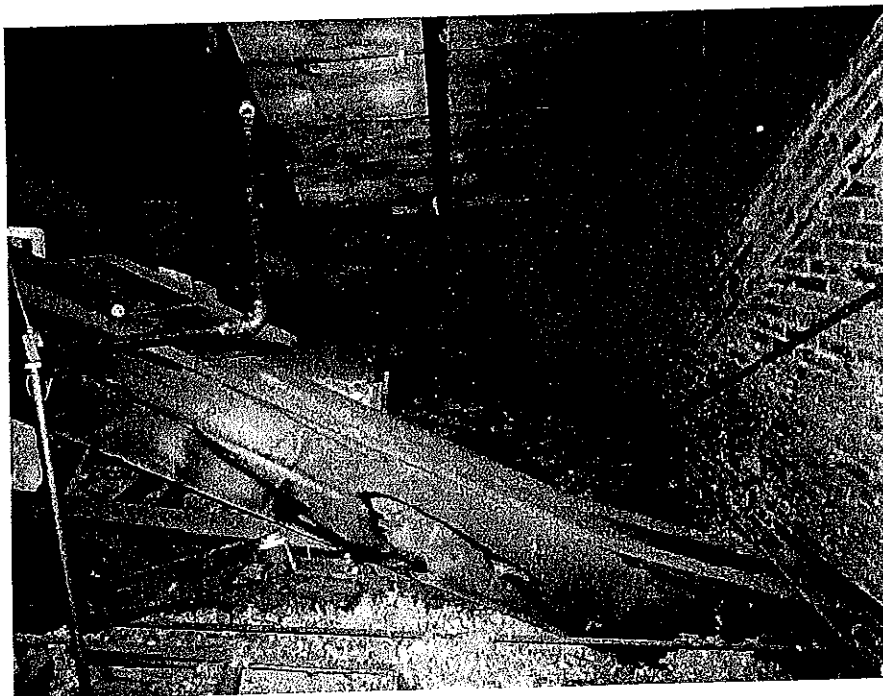
S36. Timber framing at attic entry.

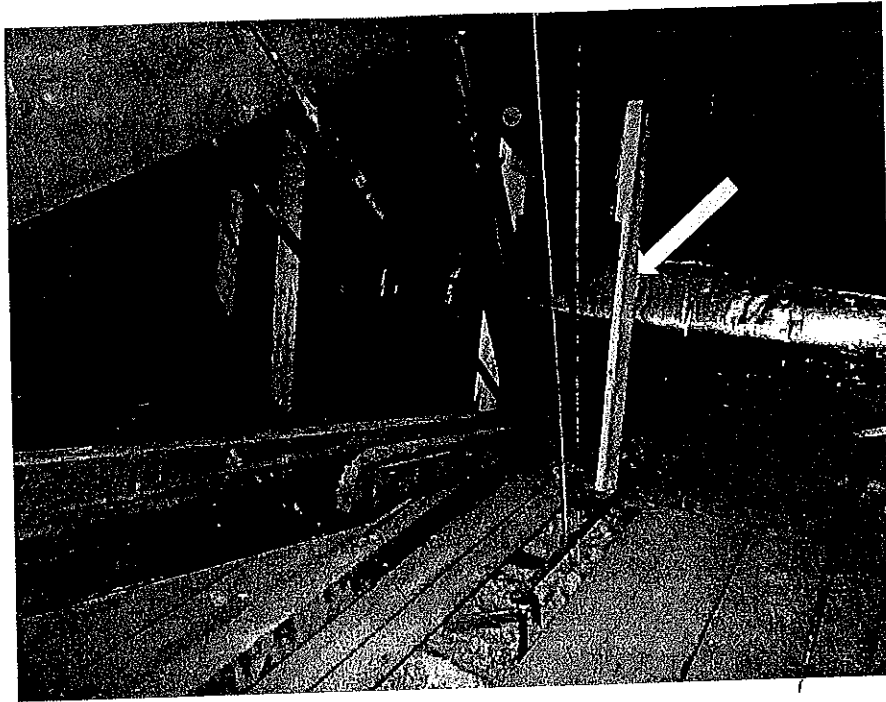
S37. Multiple timber reinforcements at timber trusses.

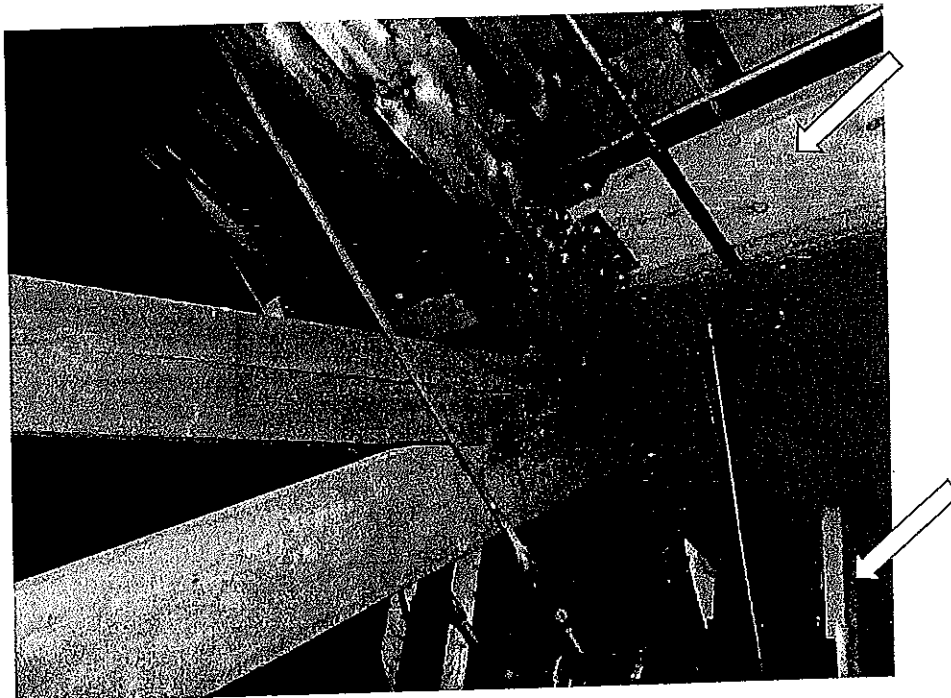
S38. Versalam and timber reinforcements at trusses.

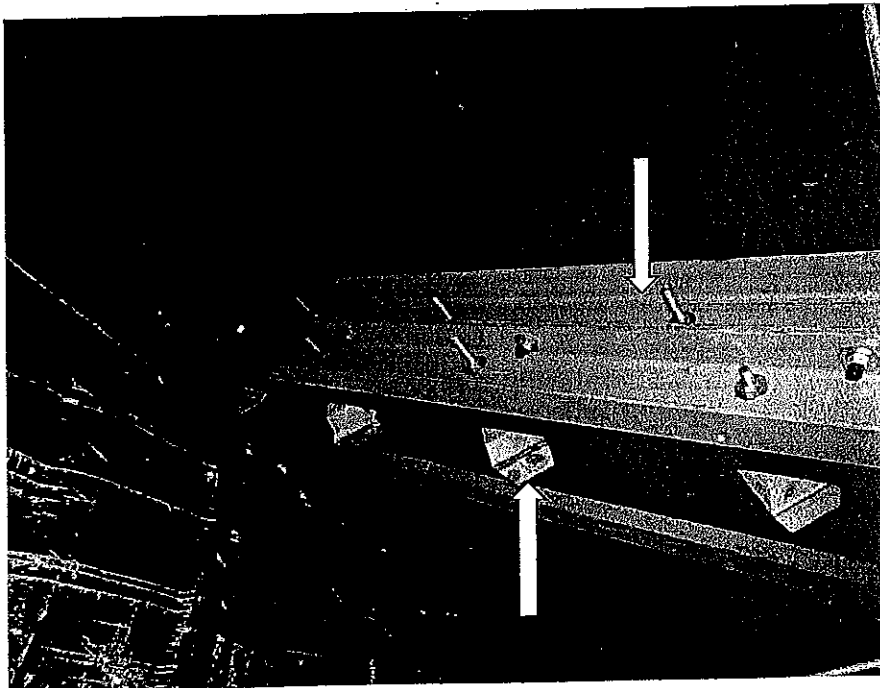
S40. Structural steel, steel tie rods, and wood reinforcements at attic trusses.

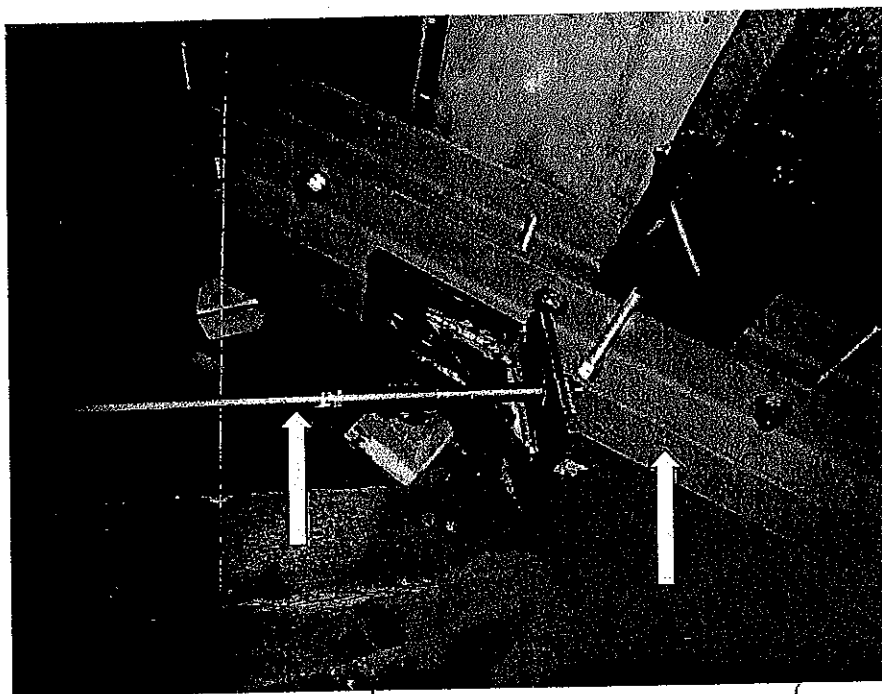
S41. Structural steel, steel tie rods, and wood reinforcements at attic trusses.

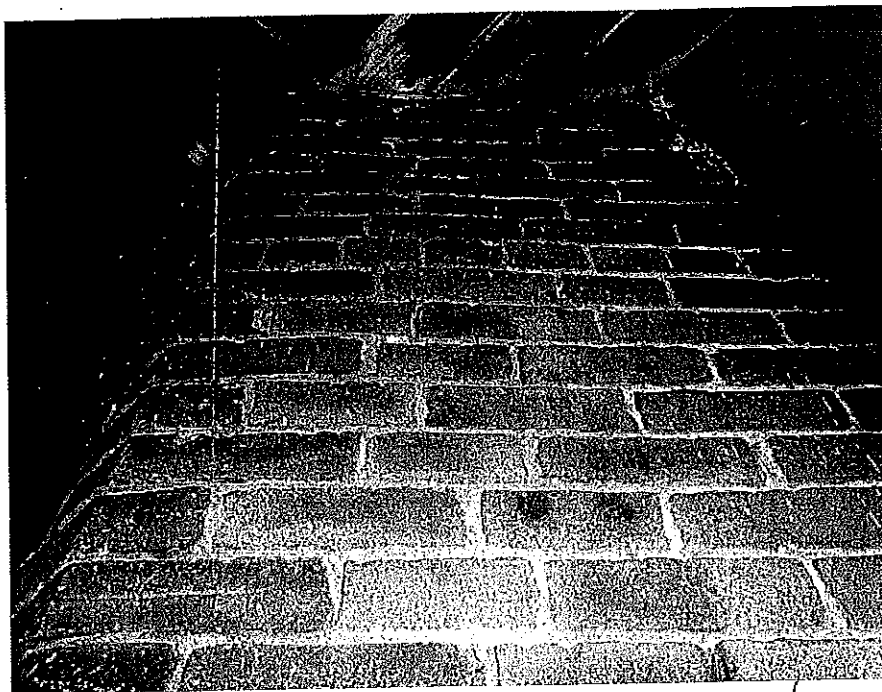
S49. Center brick cylinder structure in Clock Tower.

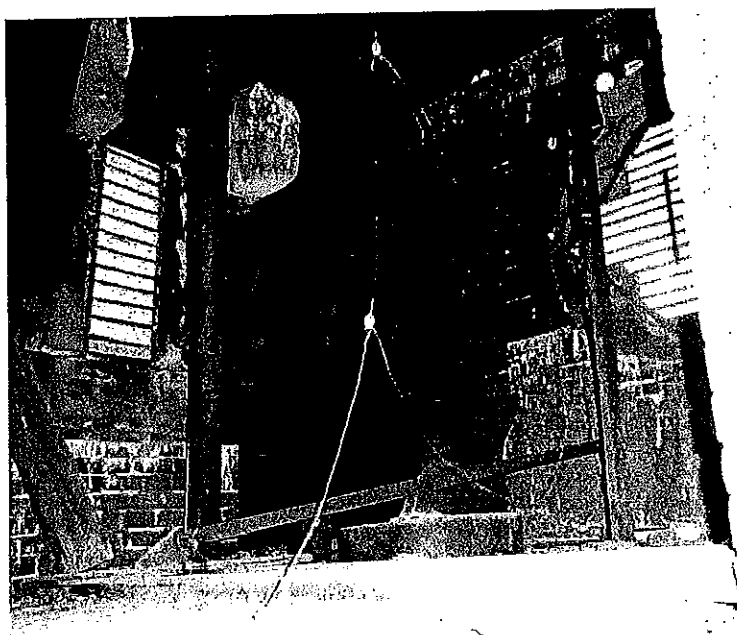
S50. Upper tower level.

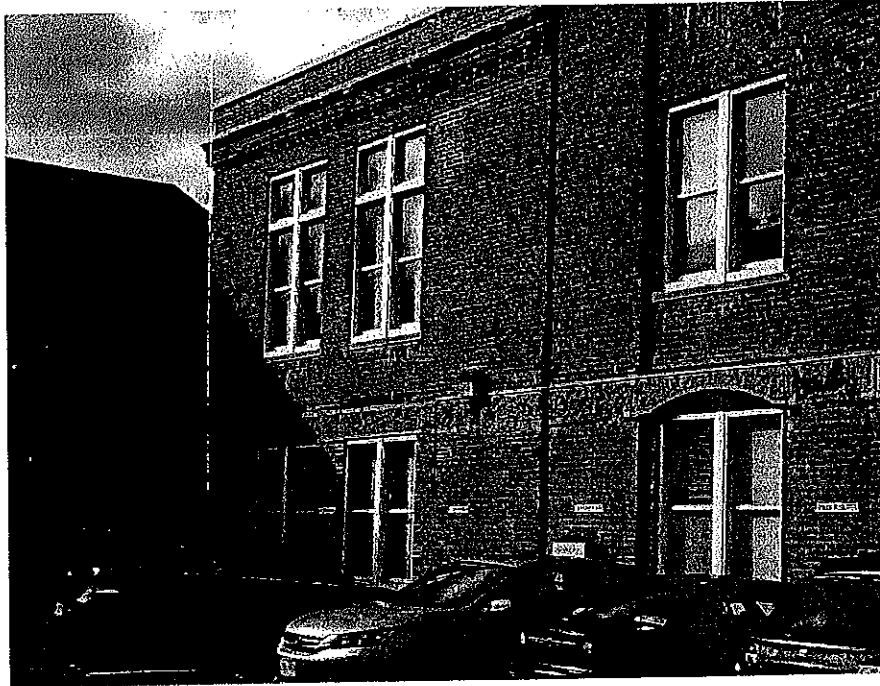
S57. East elevations of Annex Building.

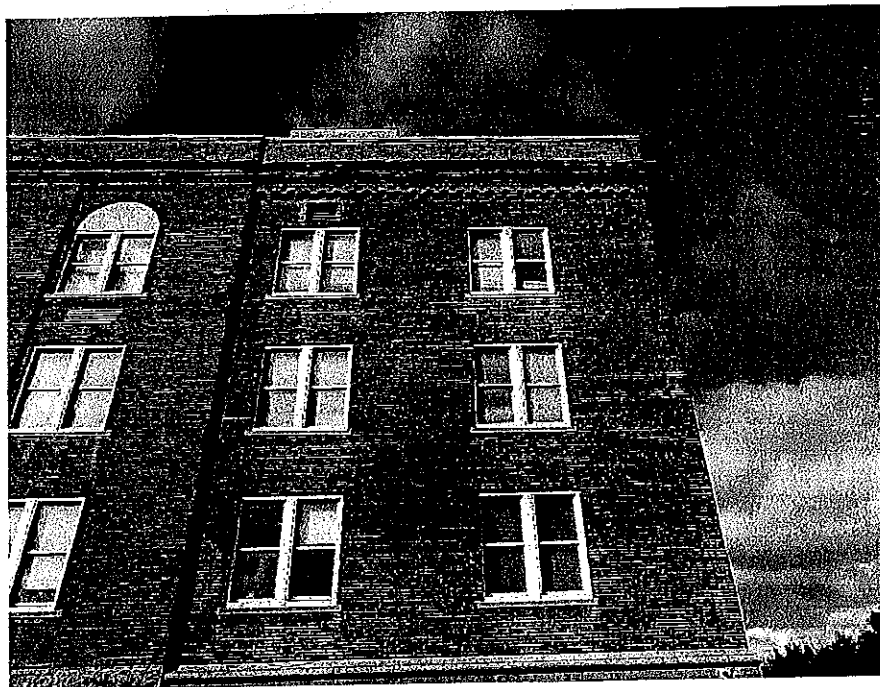
S58. East elevations of Annex Building.

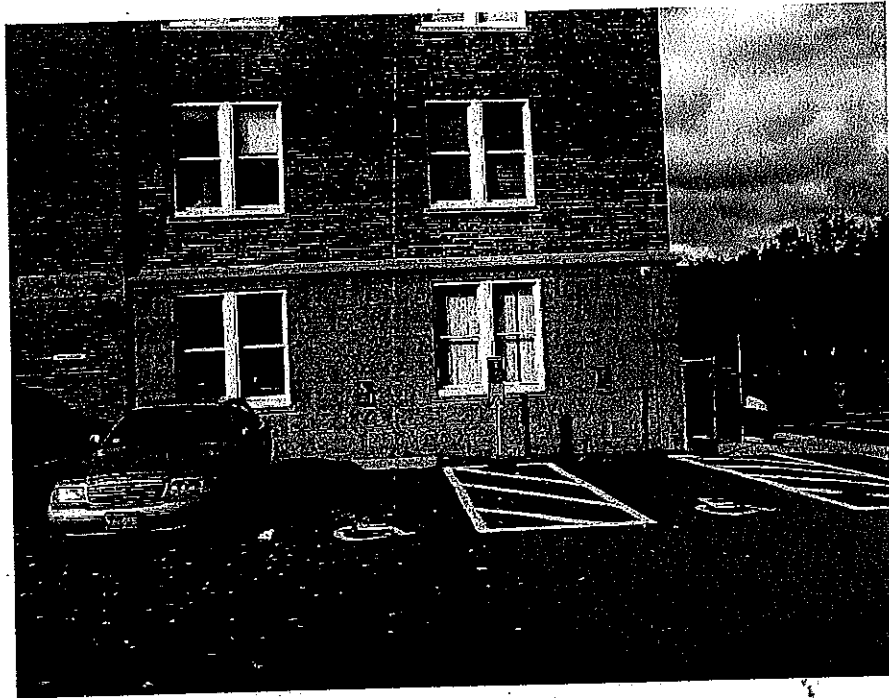
S59. East elevations of Annex Building.

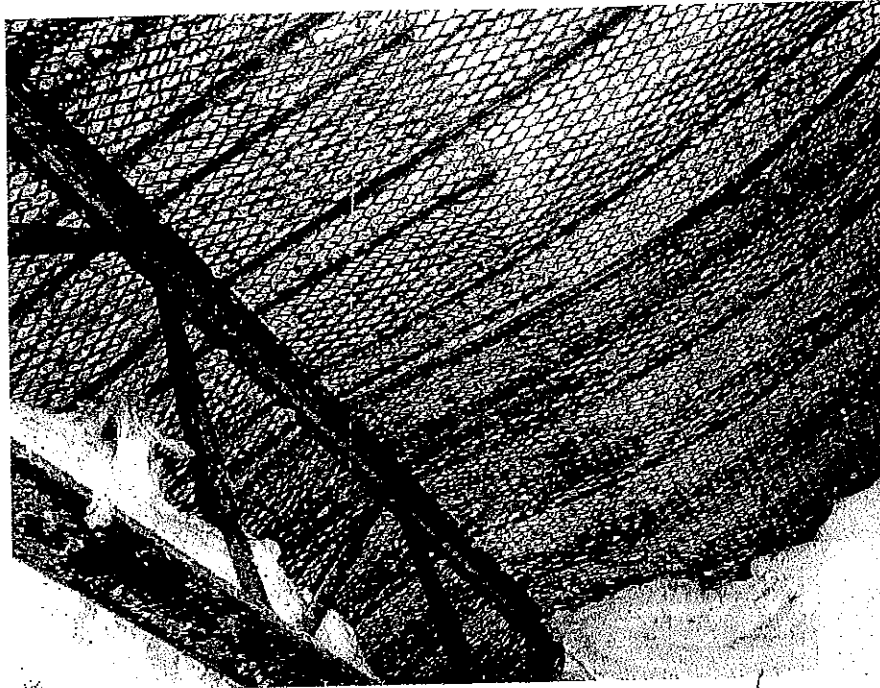
S67. Intact steel open web joists, wire mesh form for concrete floor slab in crawlspace under Annex Building.

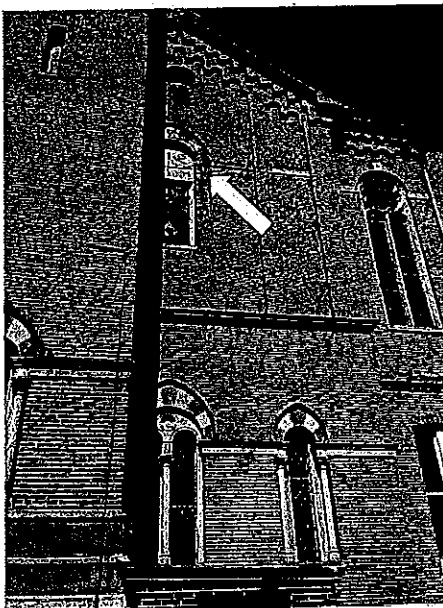
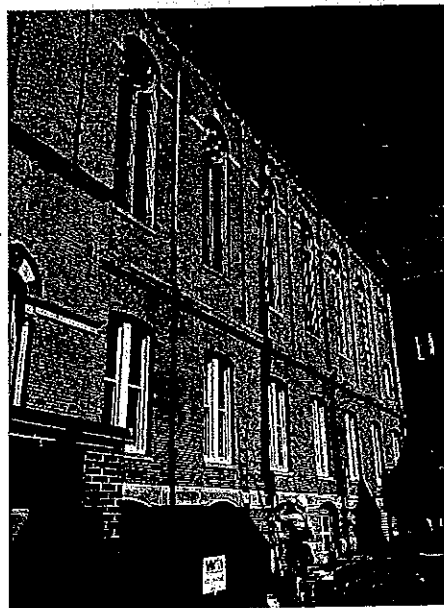
3. Photos 3a and 3b – Partial views of the Old City Hall South elevation. The gable elevation is on the left and the longitudinal elevation is on the right. At the denoted area on the gabled elevation, a plywood infill was previously installed in the arched stained glass window.

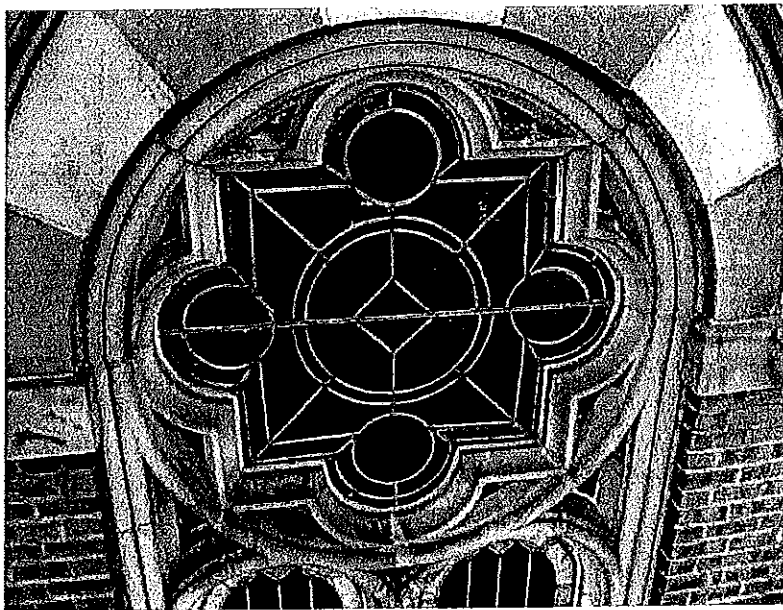
9. Photo 9 – Overall view of the rose window component of stained glass unit SG22. The tracery and stone perimeter are classified as special shapes. In this location the stone tracery along the top of the window has shifted downward.

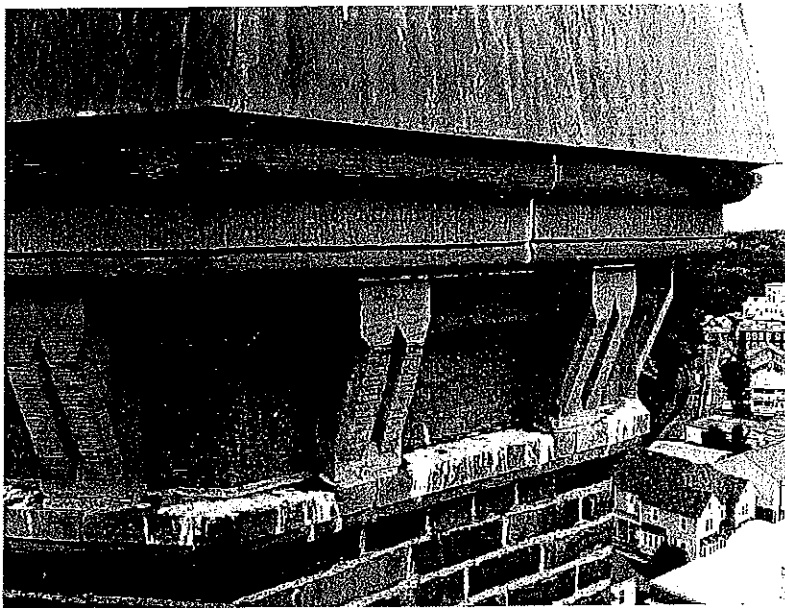
11. Photo 11—At the base of the turret roof on the Tower, the eave is constructed of several stone components including brackets that are examples of special shapes. The bird defecation on the stone cornice below the brackets should be abated. The cracks in the brackets may be a candidate for epoxy injection repair in lieu of replacement. The open mortar joints should be repointed.

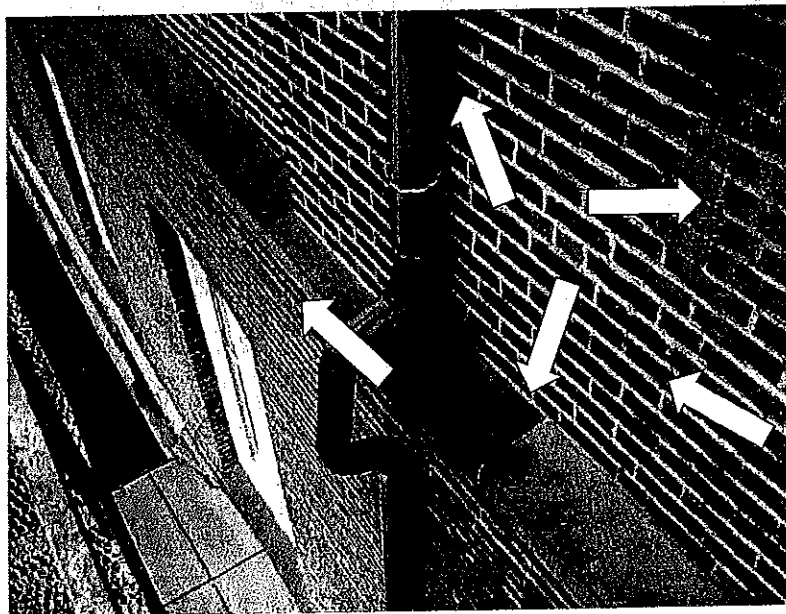
13. Photo 13 – View of the stone and brick water table on the North elevation. Note the algae growth on the top surface. Also note the environmental soiling on the stone and brick. As part of a comprehensive restoration, 100% of the masonry surfaces should be cleaned using appropriate methods and agents. Many of the mortar joints have cracked, are open, and are allowing water to wash through them and down the brick below. The coated aluminum downspout offset is not a historically accurate repair material.

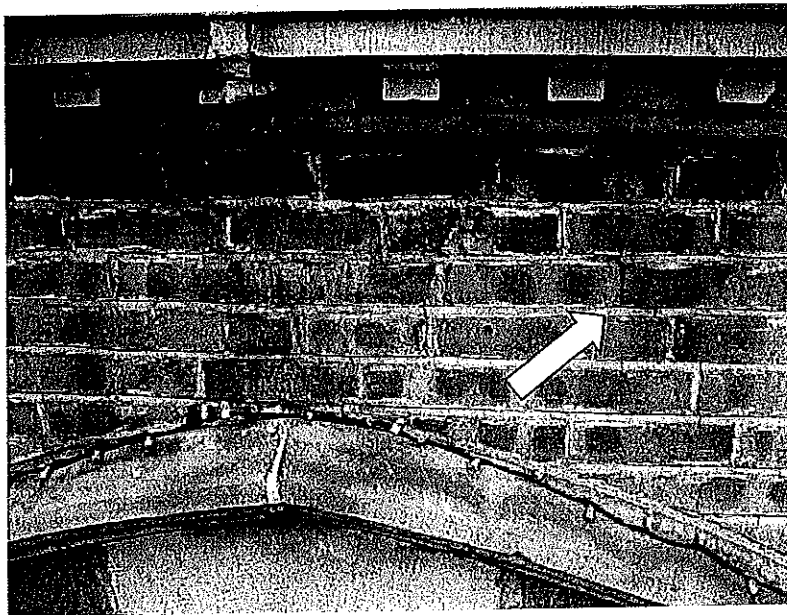
15. Photo 15 – On the West elevation, above the center arch, a step crack was observed that extends into the stone water table above as shown in photo 16.

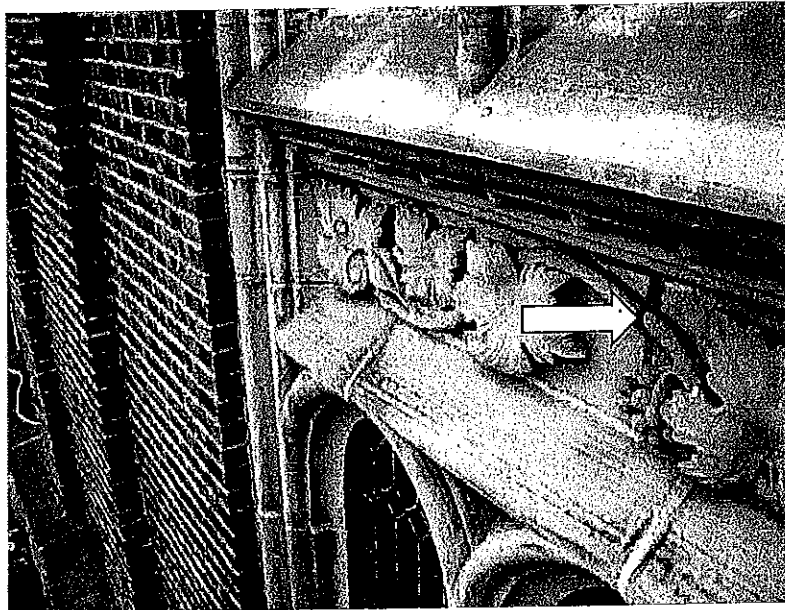
17. Photo 17 – View of the cracked floral frieze below the rose window. This was partially patched with a dense hard mortar similar to Portland cement which is not appropriate for the sandstone.

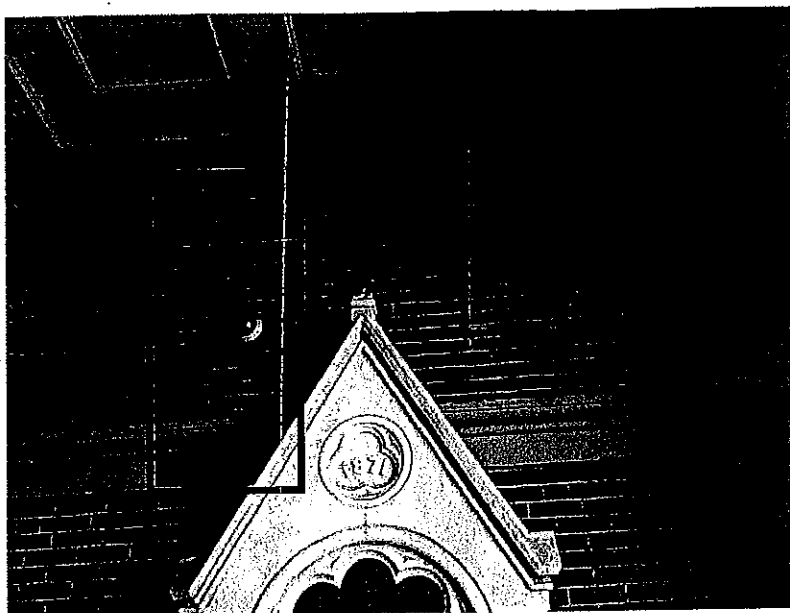
18. Photo 18 – View of the stone memorial on the South end of the alcove. Step cracks were observed in the brick above the memorial. Step cracks continue behind the memorial.

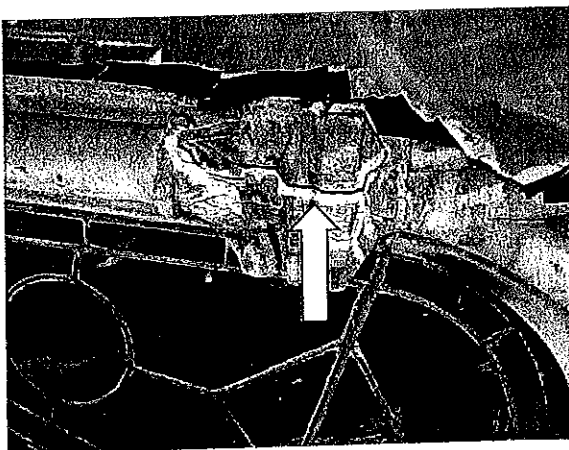
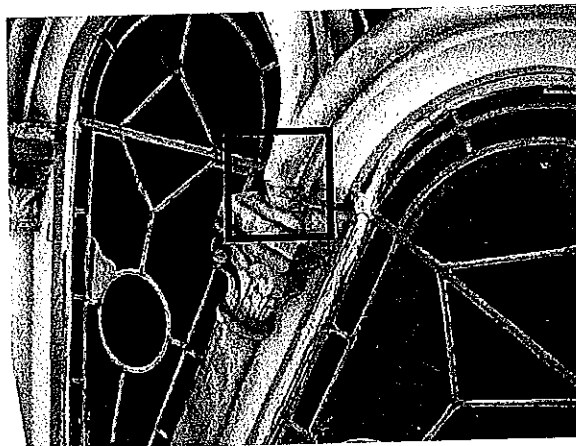
21. Photos 21a & 21b – Enlarged views of two defects within the rose window tracery. In the left photo, the connection between the spoke and the tracery has spalled and cracked at the pin connection within the capital. In the right photo, the tracery has become dislodged from the capital.

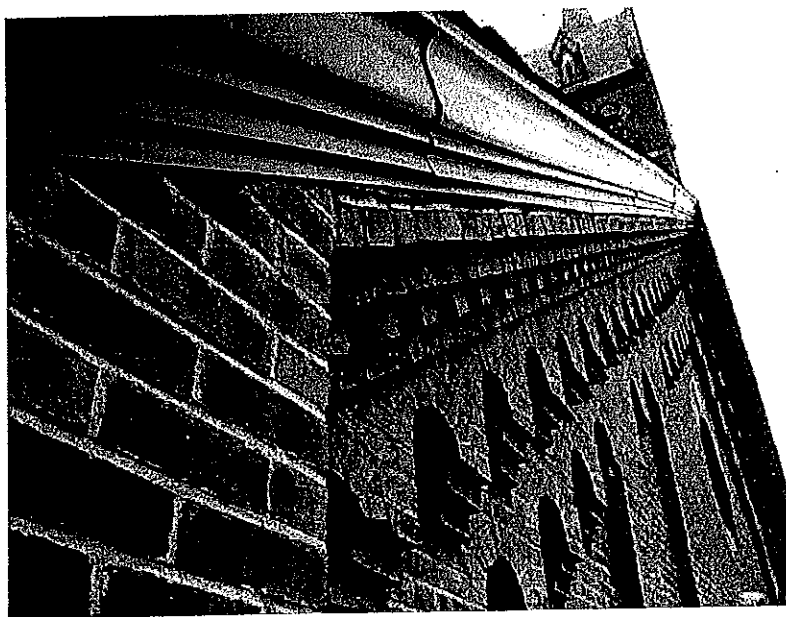
25. Photo 25 – View looking up along the North rake of the West elevation. The brick in the foreground has been rebuilt possibly as part of the 2004 repair project. The profile of the new brick and mortar is contrasted with the original brick and mortar within the arches and corbels.

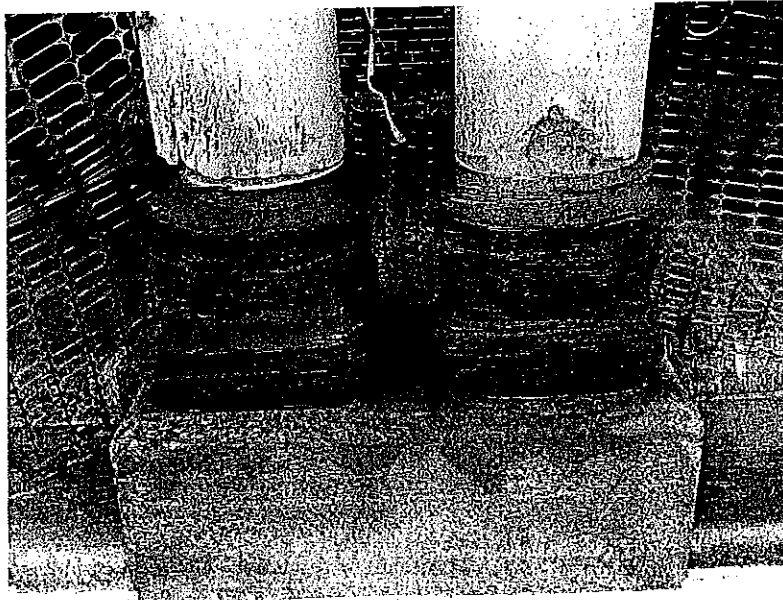
27. Photo 27 – View of the brownstone column bases that have weathered and eroded. Similarly, the bottom of the column shafts have eroded.

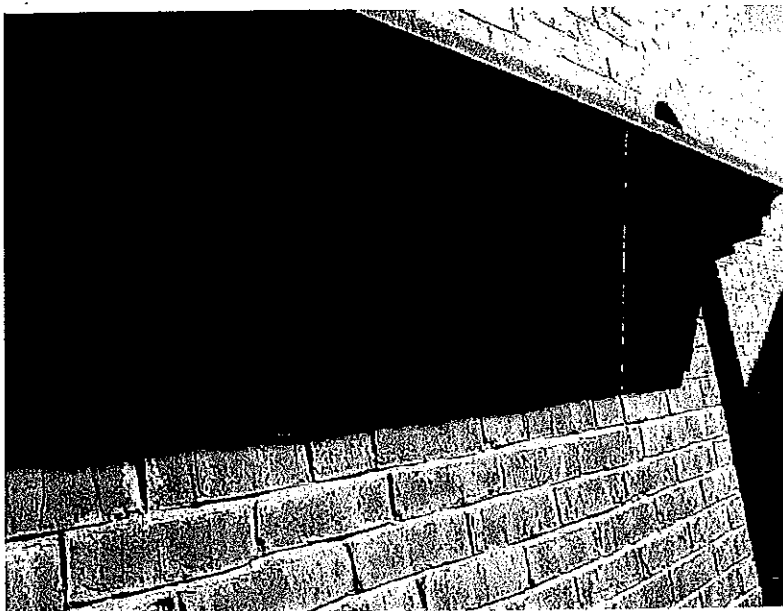
28. Photo 28 – View of the eroded underside of the stone water table on the West elevation.

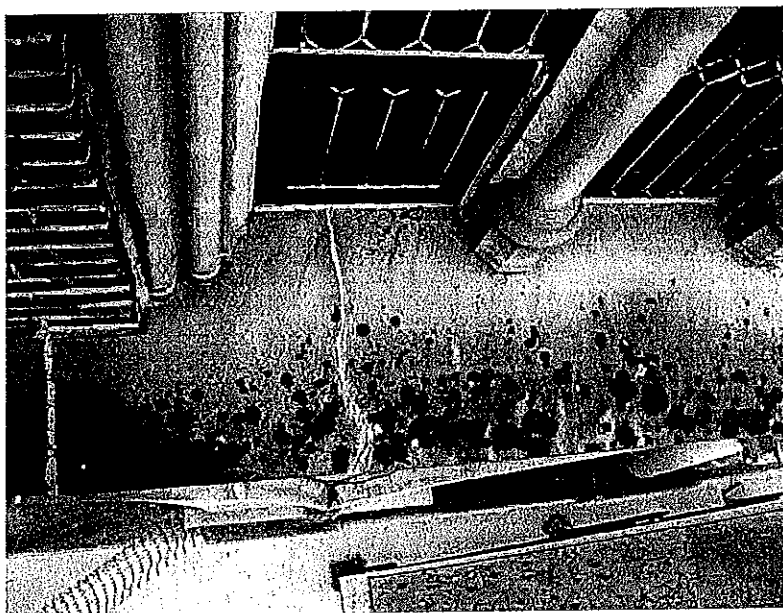
29. Photo 29 – View of the cracked stone water table on the West elevation.

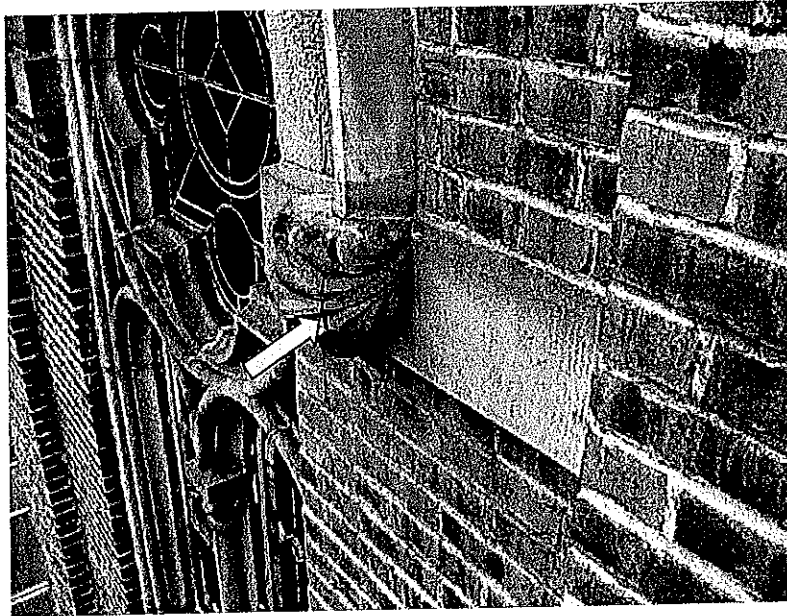
30. Photo 30 – View of the upper level stone banding and decorative floral end cap integral to the banding on the West elevation. The floral end cap is cracked in this location and several others along the elevation. At other locations, the stone banding has deteriorated.
